**Brent Mabee**  
**13 Augusta Ct**  
**Clifton Park, 12065**  
**HIN™:** 120658108  
**Email:** [jfasolino@nycap.rr.com](mailto:jfasolino@nycap.rr.com)  
**Inspection Date:** 10-05-2012

**Top Gun Inspection Services**  
**Josef Fasolino**  
**47 Crestwood Dr**  
**Schenectady, New York 12306**  
**Phone:** (518) 956-0532  
**E-Mail:** [info@topguninspectionsservices.com](mailto:info@topguninspectionsservices.com)

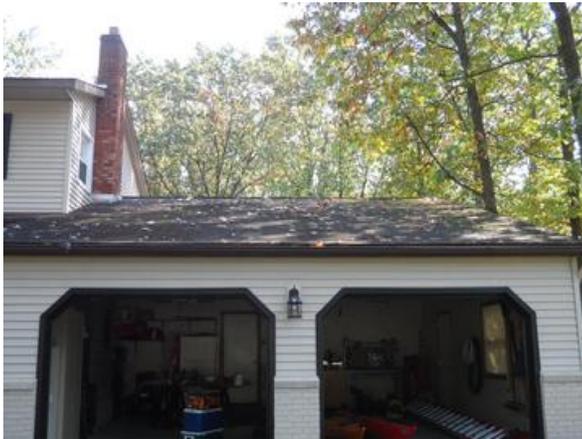
Garage

10/06/2012 Moss noted on asphalt shingles. This can lead to deterioration of roof decking due to water being leached under the shingles by the moss. Recommend a qualified contractor evaluate and repair as necessary.

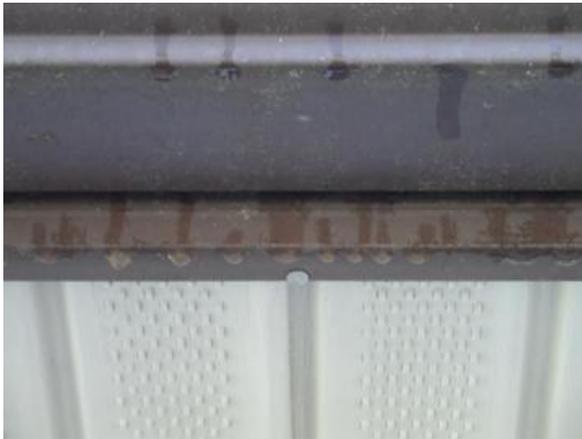
Porch Gutter

Observed a bow in the gutter along the front porch roof. Rain water will pool (collect) within the bowed section of the gutter and not properly flow toward gutter downspout. As a result, rain water may overflow the gutter causing erosion of the porch's concrete pad. Recommend to repair as necessary.

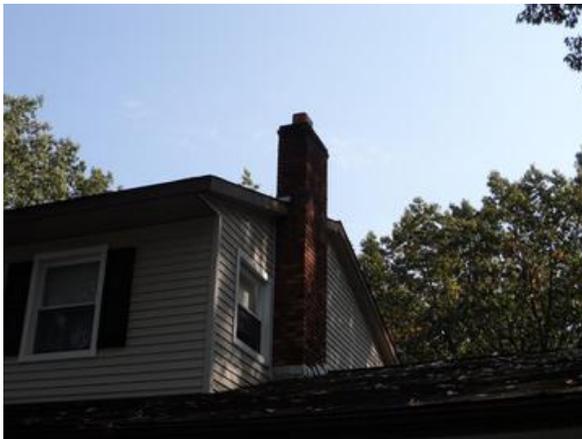
Chimney

Note, gaps between the individual roof flashing around the base of the chimney. This may allow water infiltration, leading toward roof covering de-lamination. Recommended a qualified contractor to evaluate and repair as necessary.

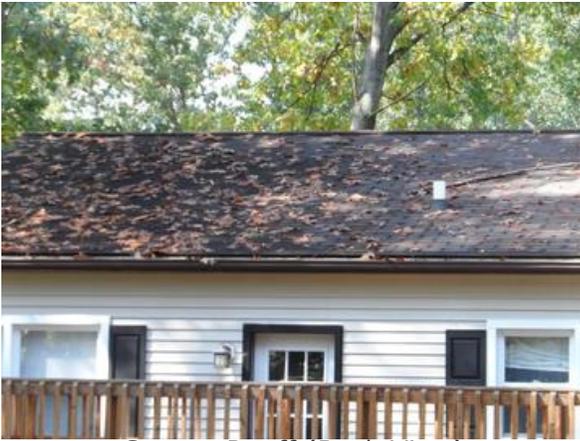
Garage Roof (Back View)

10/06/2012 Recommend cleaning gutters. This will help keep water away from foundation.

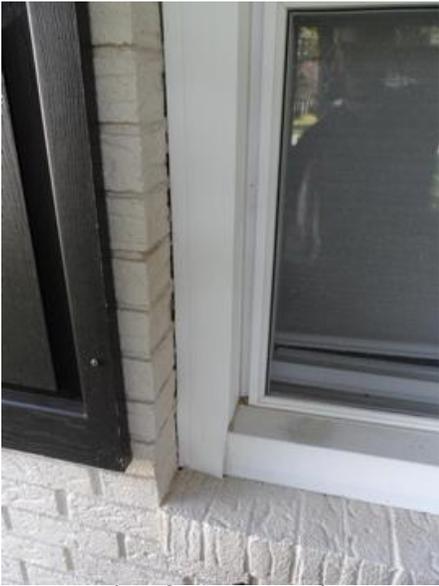
Side of Front Window

10/06/2012 Noted, missing caulking along side of front window(s) trim and brick. This may allow for water and insect infiltration. Recommend to repair as necessary.

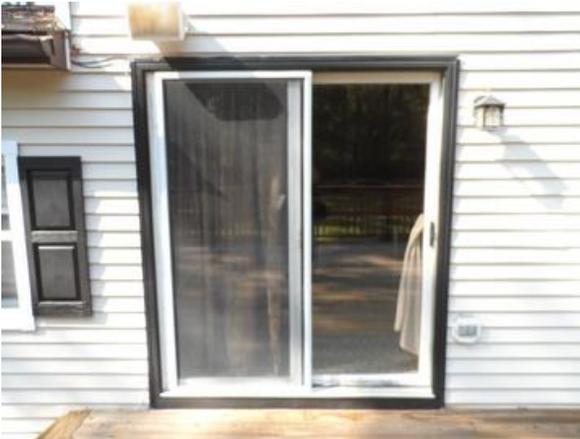
Sliding Glass Door

Observed, curling, chipped and missing paint around sliding glass door wood molding. This is exposing bare wood to the elements of nature and will cause the wood to rot. Recommend scraping and painting said areas to prevent further exposure.

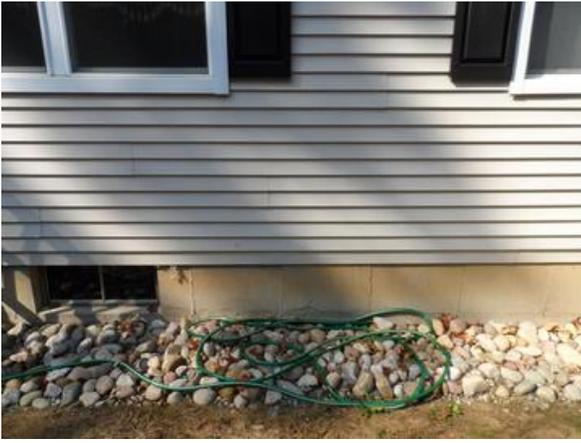
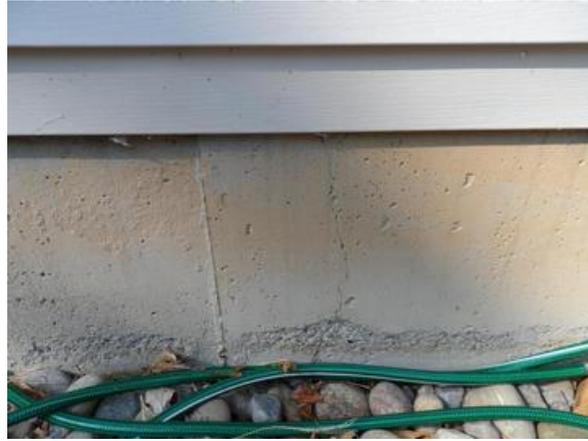
Noted small cracks in foundation. This may allow water infiltration which could lead to further damage. Recommend to contact a qualified contractor to evaluate the small foundation cracks and repair as necessary. (Note, the owner stated since living in the house, they had no water infiltration)

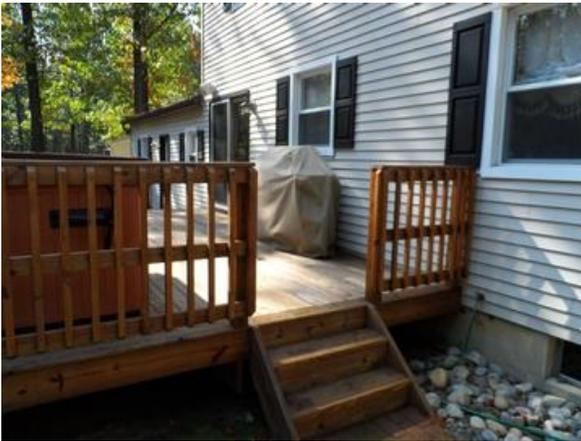
Deck Stairs

Note, a very slight moment in the deck guardrails. This is considered a potential safety hazard, due to personal injury. Recommend a qualified contractor to evaluate this slight movement and repair if necessary.

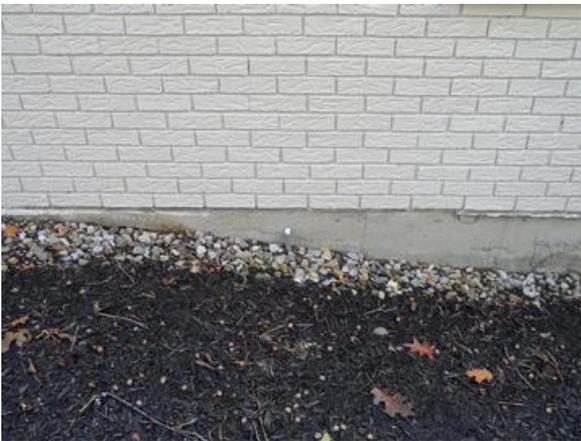
Front of House

Observed, the concrete opening around the pipe is large enough for insect infiltration. Recommend to repair as necessary.

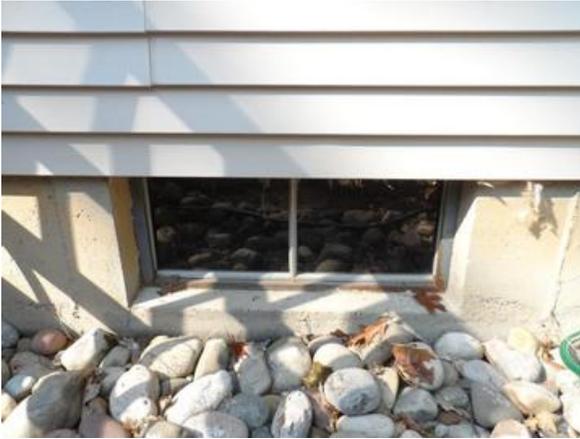
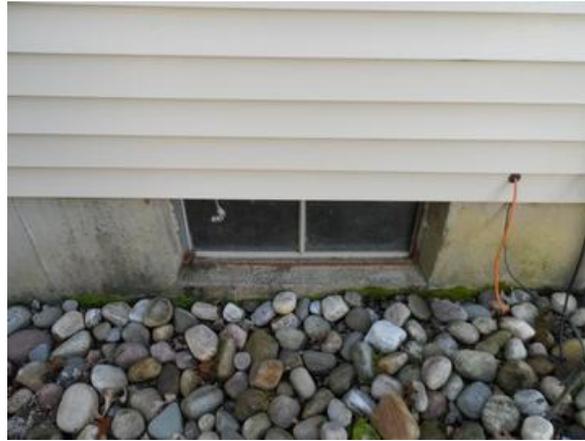
10/10/2012 Note, the metal window(s) basement frames are rusting. This is considered a maintenance issue and further neglect may could lead to deterioration of the metal frames. Recommend maintaining as necessary.

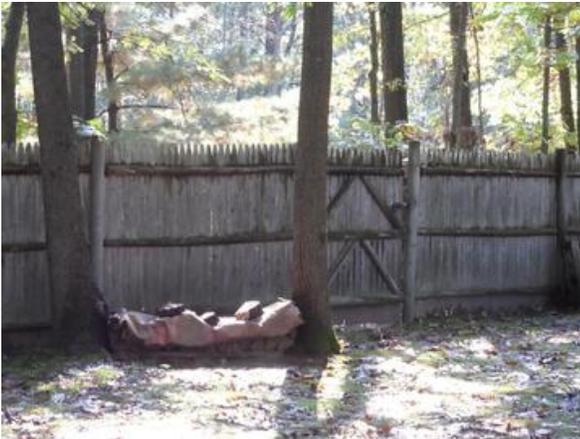
Fence in Backyard

10/10/2012 Observed, several fence posts that were loose. This is considered a maintenance issue. Recommend maintain / repairs as necessary.

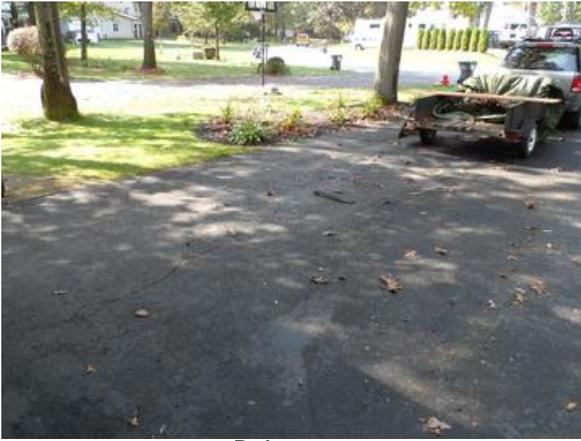
Driveway

10/10/2012 Note, many cracks were observed in the asphalt driveway. Currently, this is considered a maintenance issue and further neglect may lead to further deterioration. Recommend to repair as necessary

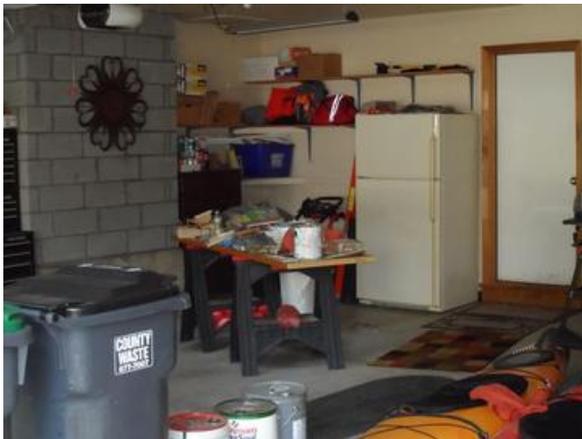
Garage / Entrance into House

10/10/2012 Garage-house door isn't auto-closing. Recommend installing hinges with springs or an automatic door closing device so door closes automatically to prevent vehicle fumes from entering building.

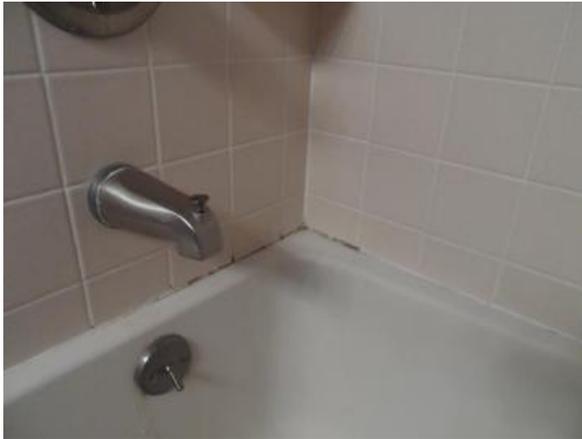
2nd Floor Bathroom

10/10/2012 Noted missing caulk in bathtub area. This will allow water penetration to effect sub flooring and may damage wood. Recommend a qualified contractor repair or replace as necessary.

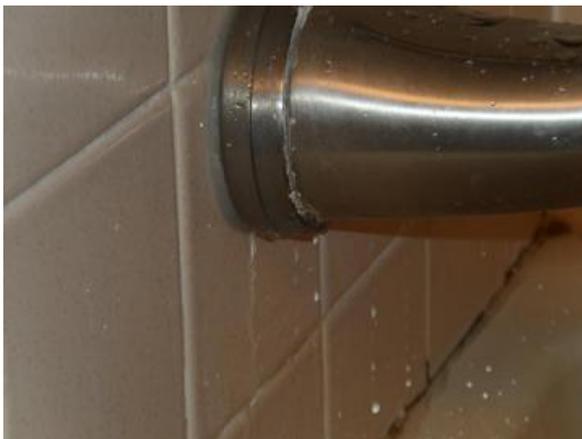
Leak at Faucet

10/10/2012 During the functional operation of the bathtub, noted, a leak at the bathtub faucet. A leaking faucet may allow water penetration behind the sheetrock, leading to deterioration and/or mold. Recommend a qualified contractor to evaluate and repair as necessary.

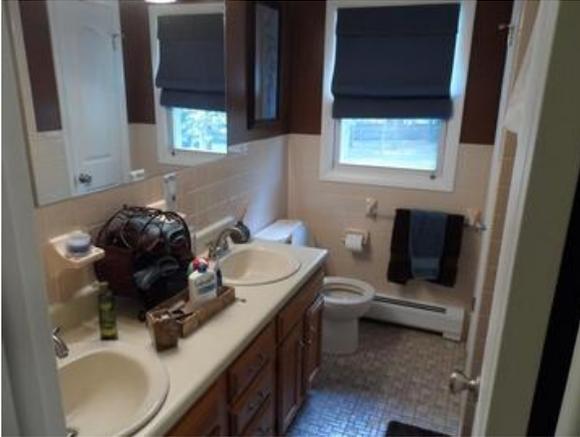
2nd Floor Bathroom

Similar to the general interior section of this report, the bathroom window doesn't stay open. Once open, the window immediately shuts. Recommend to repair as necessary due to the potential safety hazard.

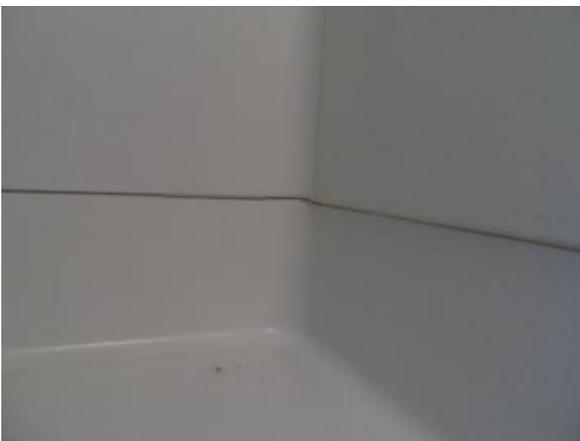
1st Floor Bathroom

Noted missing caulk in shower area. This will allow water penetration to effect sub flooring and may damage wood. Recommend a qualified contractor repair or replace as necessary.

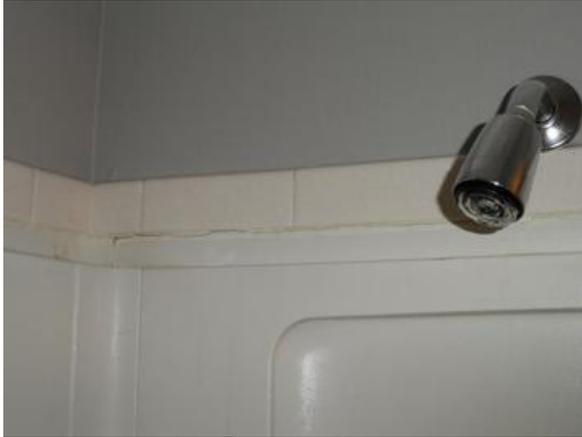
1st Floor Bathroom

10/10/2012 Noted missing caulk on top of the shower stall. This may allow water infiltration, leading toward deterioration behind the shower panel and mold. Recommend a qualified contractor repair or replace as necessary.

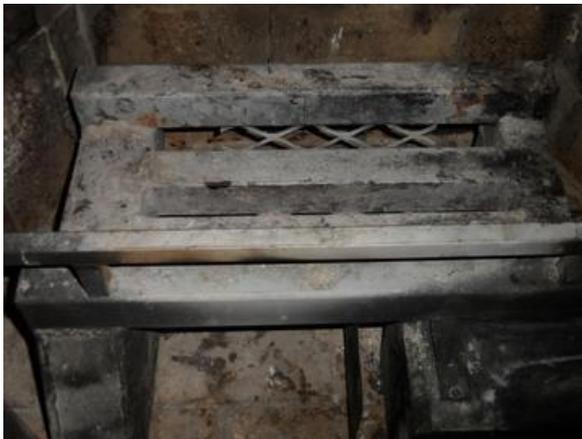
Inside the Fireplace

10/10/2012 Note, a few small mortar cracks on the floor and wall. This could be a safety hazard. Recommend to contact a qualified contractor to evaluate and repair as necessary.

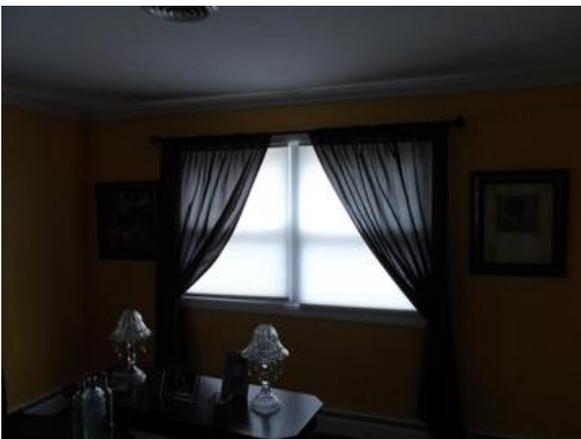
Living Room

10/10/2012 Observed, several windows throughout the house shut immediately, once open. This is considered a safety hazard due to the potential of personal injury. Recommend a qualified contractor to evaluate and repair as necessary.

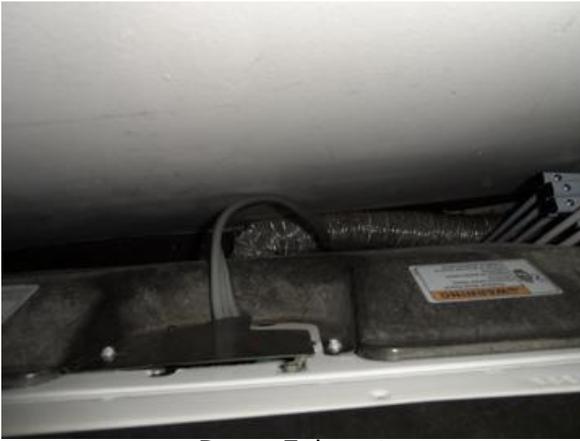
Dryer Exhaust

The clothes dryer is equipped with a metal, accordion-type, flexible exhaust duct. The U.S. Consumer Product Safety Commission considers these types of ducts to be unsafe, and a fire hazard. These types of ducts can trap lint and are susceptible to kinks or crushing, which can greatly reduce the air flow. This duct should be replaced with a rigid or corrugated semi-rigid metal duct, and by a qualified contractor if necessary. For more information on dryer safety issues, see <http://www.cpsc.gov/CPSCPUB/PUBS/5022.html>.

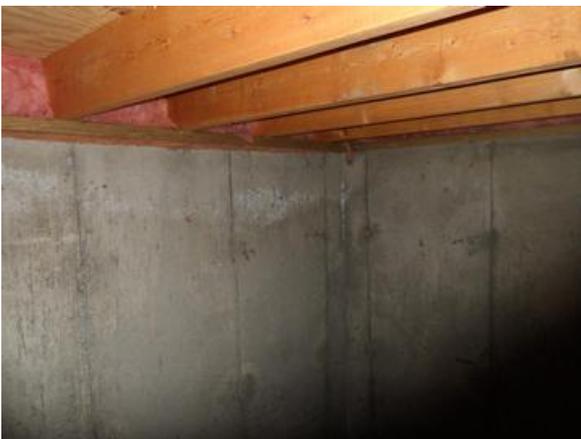
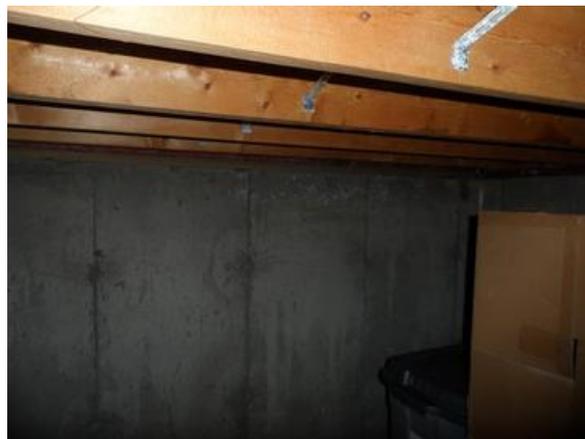
Some beginning signs of efflorescence along the foundation wall. This is early signs of water infiltration. Recommend a qualified contractor to evaluate and repair as necessary.

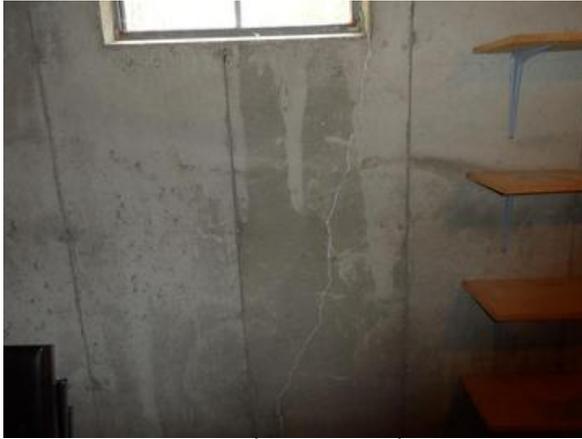
Foundation Crack

10/10/2012 Observed, vertical foundation cracks. Owner stated the cracks have been there since he has purchased the house. Recommend for a qualified contractor to evaluate the foundation cracks and repair if necessary.
