Mold Reference Guide: Top Gun Classifications

Class A: Mold around Nails

Class C: Mold greater than 10 ft²

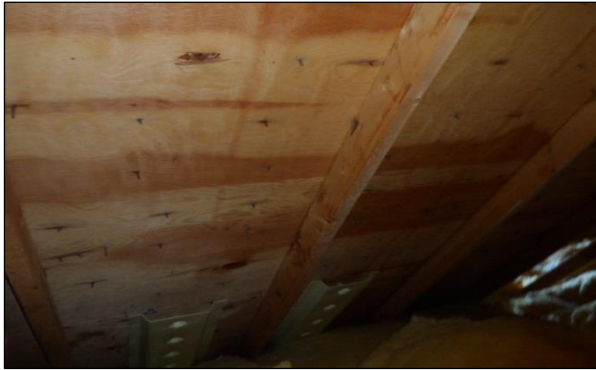
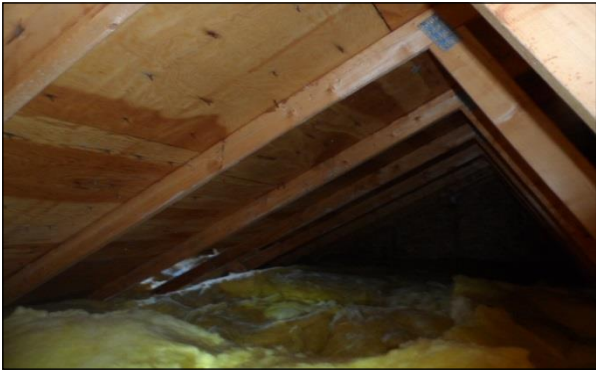
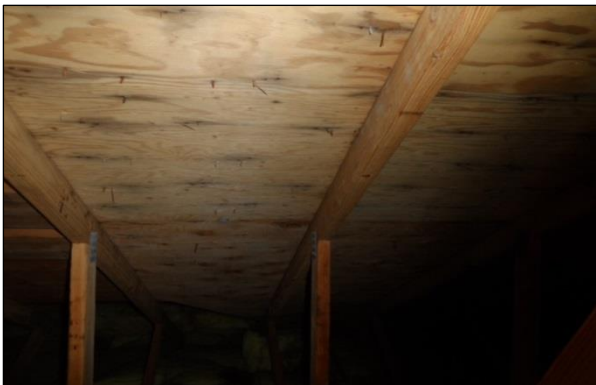
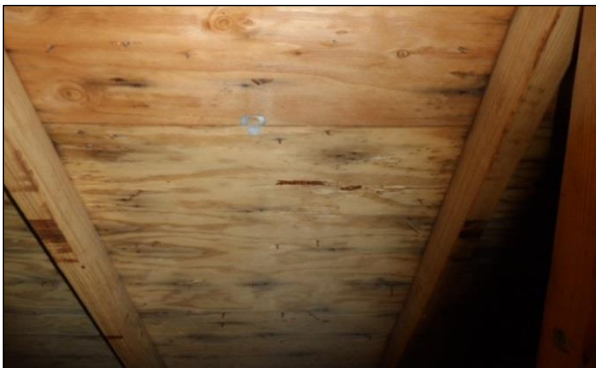
This is the beginning signs of microbial growth. This is due to the lack of ventilation and the presence of humidity in the attic. The nail acts as a thermal bridge transferring energy from the outdoors into an elevated (temperature) attic; resulting with condensations forming on the nail.

Ventilation is substandard in the attic. Inadequate attic ventilation may result in high attic and roof surface temperatures; reduce the life of the roof covering materials and increase cooling costs. Recommend to contact a qualified contractor to evaluate the attic ventilation design and to repair as necessary.

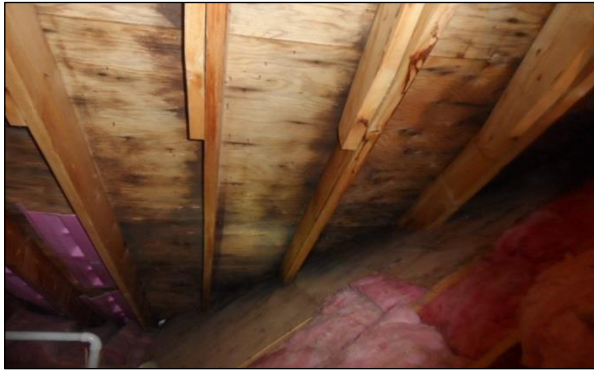
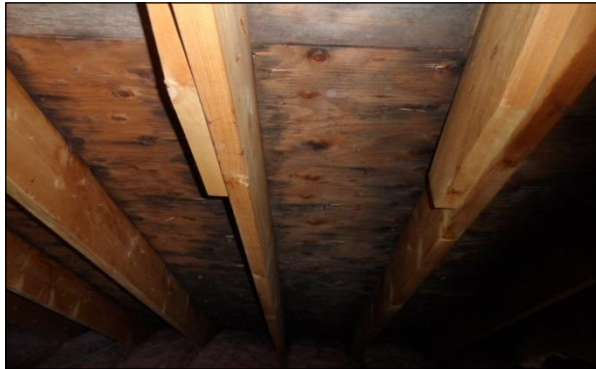
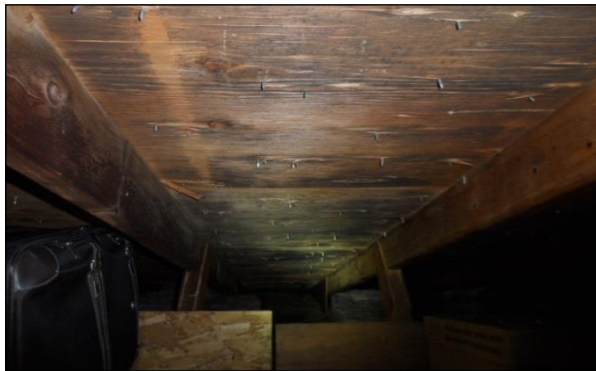
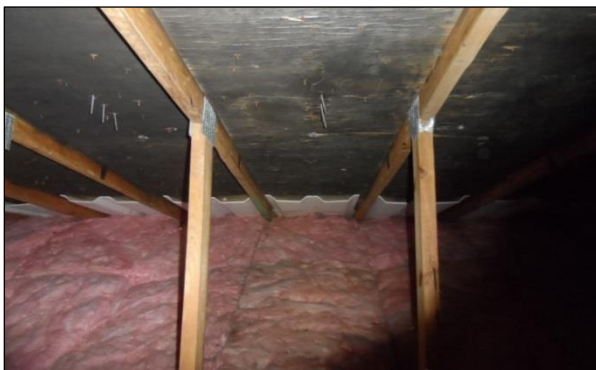
Observed an mold-like substance greater than 10 ft² along the attic decking, which requires remediation. Remediation may be performed by the homeowner or by a NYS License Remediation Company. If a remediation company is requested, an NYS License Mold Assessor is necessary to perform a pre and post mold assessment prior to any remediation.

As document per the Environmental Protection Agency (EPA), the presence of a mold like substance is considered a health concern. For example, inhaling or touching mold or mold spores may cause allergic reactions in sensitive individuals. Allergic responses include hay fever-type symptoms, such as sneezing, runny nose, red eyes, and skin rash (dermatitis). Allergic reactions to mold are common. The presence of mold in the attic may be due to lack of ventilation and/or generation of moisture. Recommend to contact a New York State License Mold Assessor to evaluate the mold like substance along the sheathing in the attic and to provide the appropriate actions and resolution. This defect is identified as a major defect that will cost greater than \$1500 in services.
