**Brent Mabee**  
**13 Augusta Ct**  
**Clifton Park, 12065**  
**HIN™:** 120658108  
**Email:** [jfasolino@nycap.rr.com](mailto:jfasolino@nycap.rr.com)  
**Inspection Date:** 10-05-2012

**Top Gun Inspection Services**  
**Josef Fasolino**  
**47 Crestwood Dr**  
**Schenectady, New York 12306**  
**Phone:** (518) 956-0532  
**E-Mail:** [info@topguninspectionsservices.com](mailto:info@topguninspectionsservices.com)

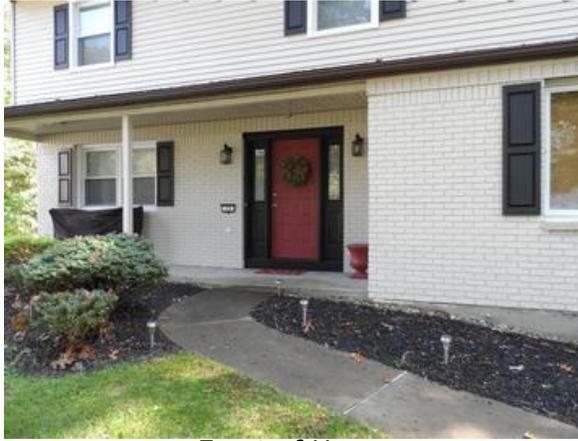
Front of House

10/06/2012 Noted, missing caulking along side of front window(s) trim and brick. This may allow for water and insect infiltration. Recommend to repair as necessary.

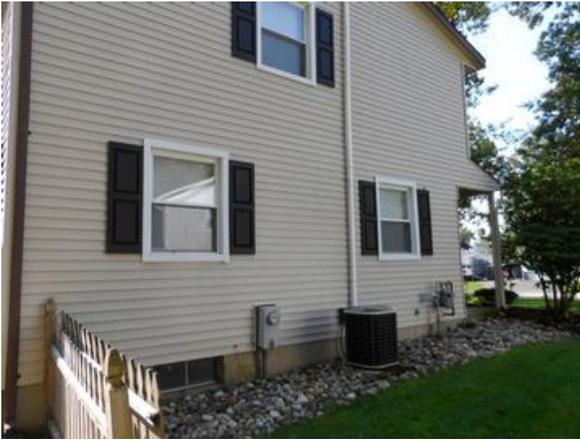
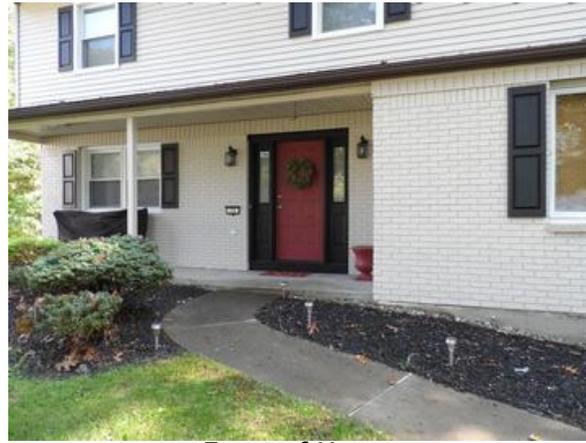
Front of House

10/06/2012 Observed no damage to the vinyl siding

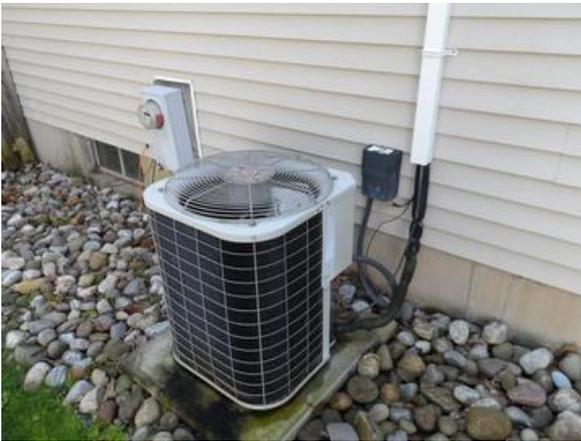
AC Unit

10/06/2012 Due to cool ambient temperatures the evening before, the AC unit was not tested. No defects were found with the concrete pad.

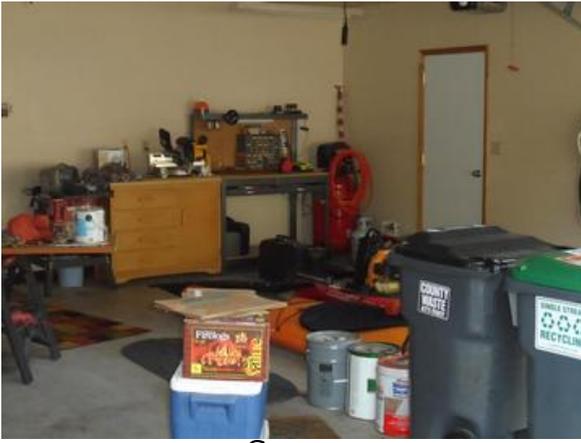
Garage

10/10/2012 Due to the stored items within the garage, visually inspection of the walls and floor were limited.

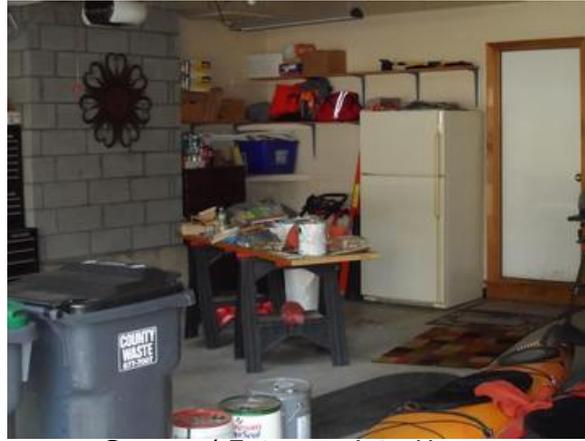
Garage / Entrance into House

Garage-house door isn't auto-closing. Recommend installing hinges with springs or an automatic door closing device so door closes automatically to prevent vehicle fumes from entering building.

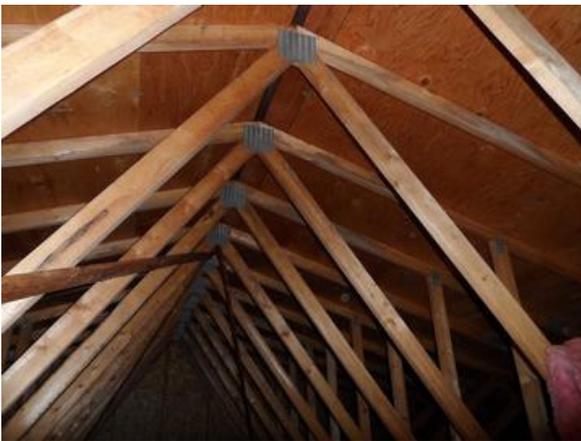
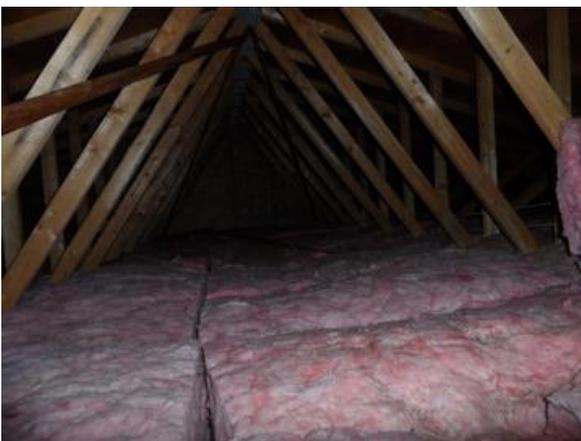
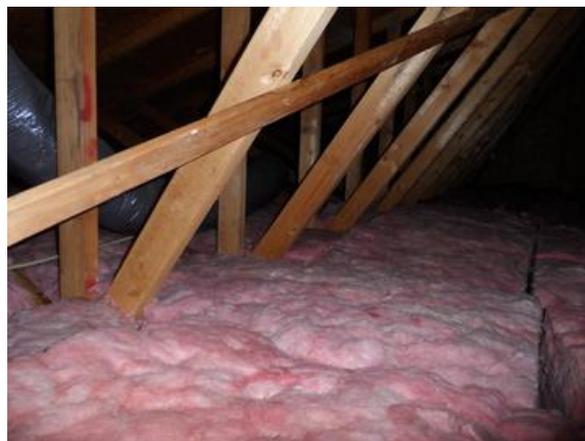
Garage Attic

Note, the visual inspection of the garage attic was limited due to restricted access. No defects were found the day of the inspection.

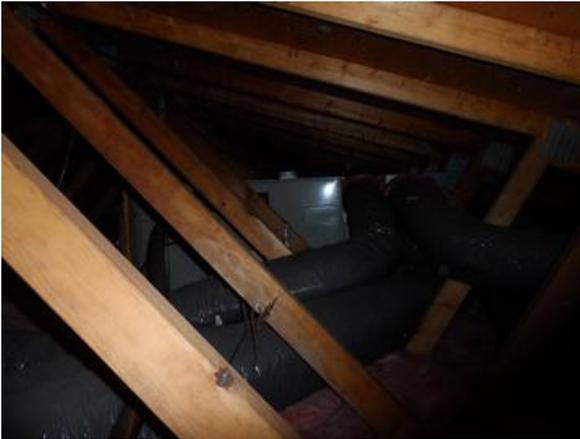
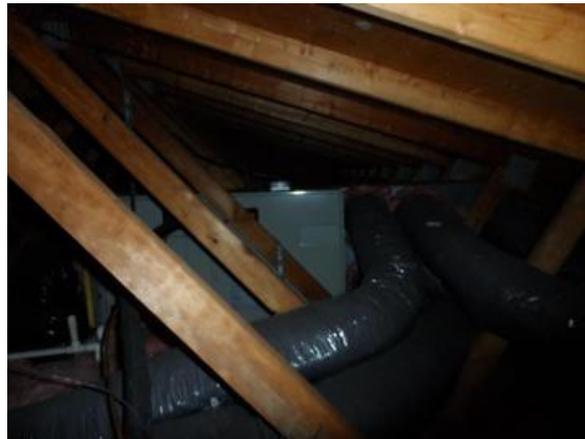
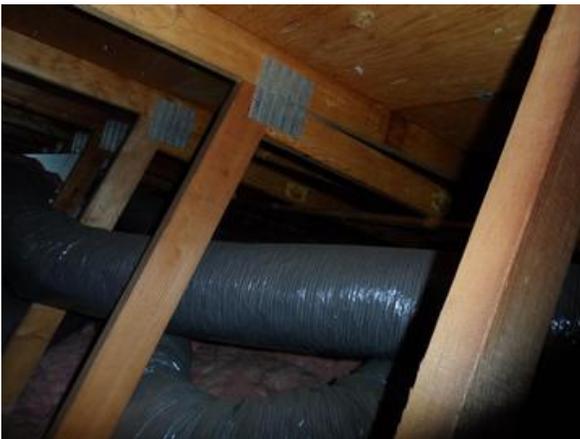
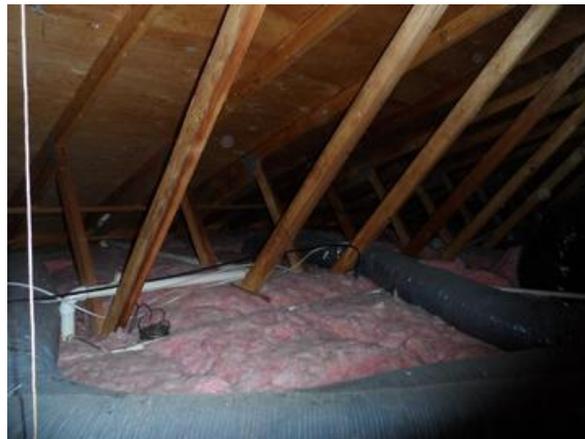
Attic

10/10/2012 Noted, visual inspection of the attic was limited, due to access within the attic.  
No defects were noted.

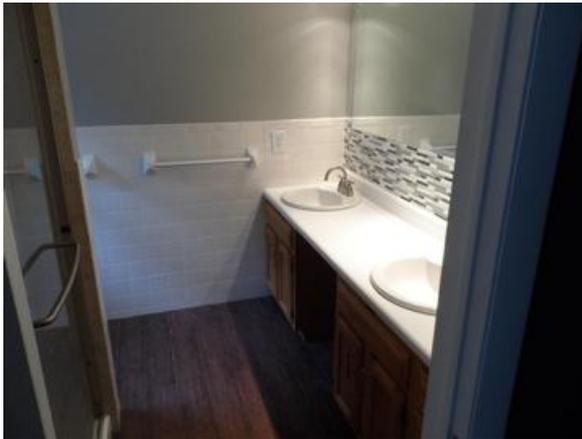
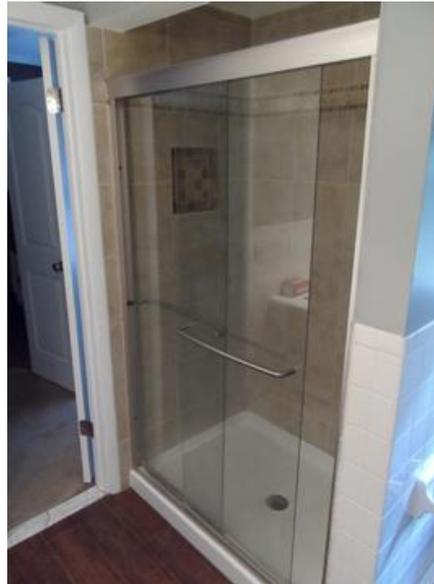
Master Bathroom

10/10/2012 No defects noted in bathroom.

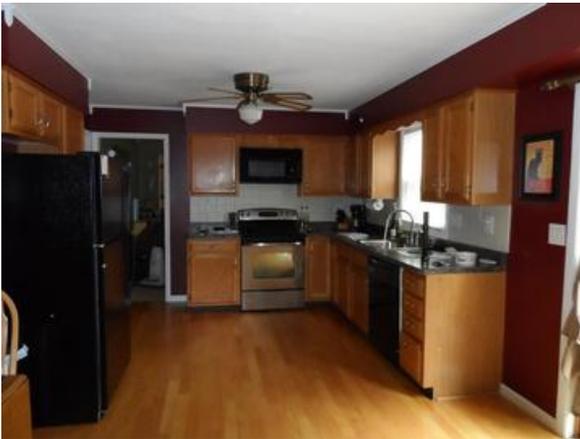
Kitchen

10/10/2012 There were no apparent defects in the kitchen.

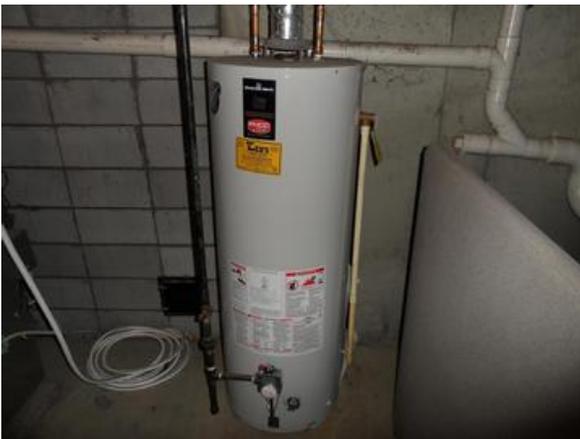
Water Tank

10/10/2012 Hot water heater operated as designed on the day of the inspection.

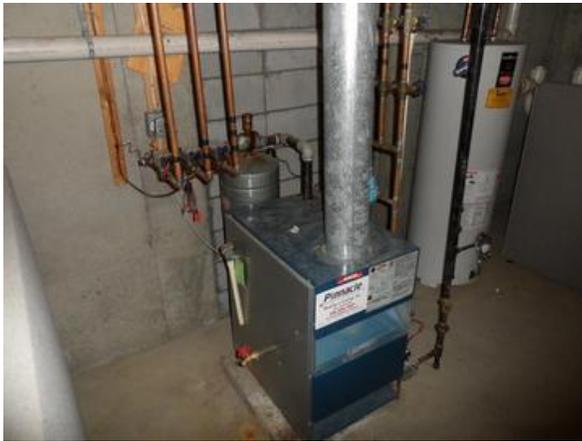
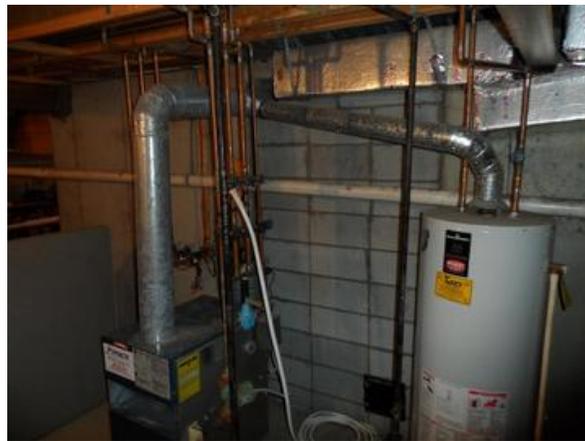
Furnace

10/10/2012 System operated as designed on day of inspection.

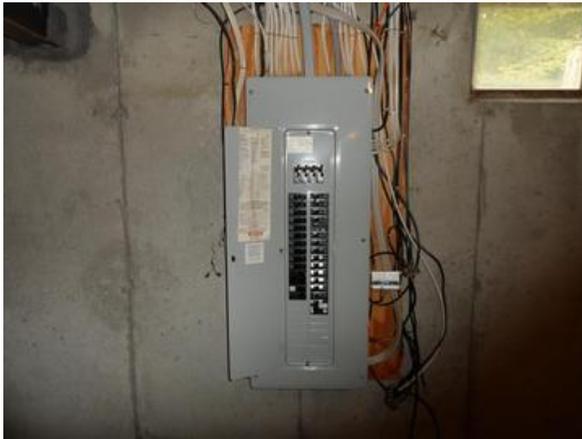
Electrical Panel

10/10/2012 There were no visible defects in panel at time of inspection. System worked as designed.

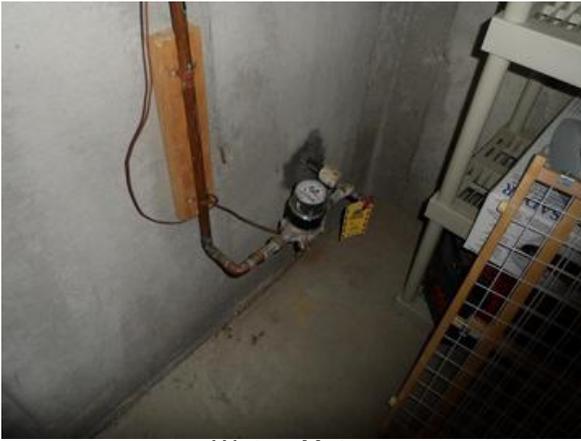
Water Meter

10/10/2012 Water was run at the kitchen sink for the duration of the inspection. There were no active leaks noted at time of inspection.
